# Diagnostic Evaluation of Chronic Venous Insufficiency Cases Using Thermal Imaging

The use of infrared thermography in surgery of Varicose Veins on the inferior limbs is presented. The study was executed at Polytechnic Institute of Bragança and at the Regional Hospital of Bragança, Portugal. The most suitable steps to measure with this technology were determined prior to the clinical studies, where a minimum waiting time of 10 minutes was determined for each individual to reach thermal equilibrium. Both inferior limbs were compared for each patient and it was found that in 75% of the cases there was an aggravation of the healthier leg. In one of the cases residual veins appear. It was concluded that regular thermographic exams on post-operative allow a closer follow up of the recovery of the operated limb, as well as the evolution of the non-operated limb.

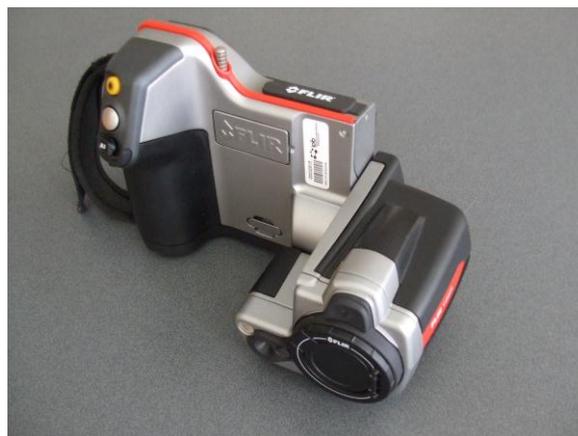
Fig. 1 - Camera FLIR®, T365 model.

A particular protocol for a FLIR®, model T365, camera (Fig. 1) was developed for this pathology. This protocol differs from Bagavathiappan et al. (1)

A black background was also used to avoid temperature contamination of the surroundings and the capture of images was made from multiple angles. It was considered an emissivity of 0.98, the relative humidity (50%) and the distance from camera to the object (0.50 m).

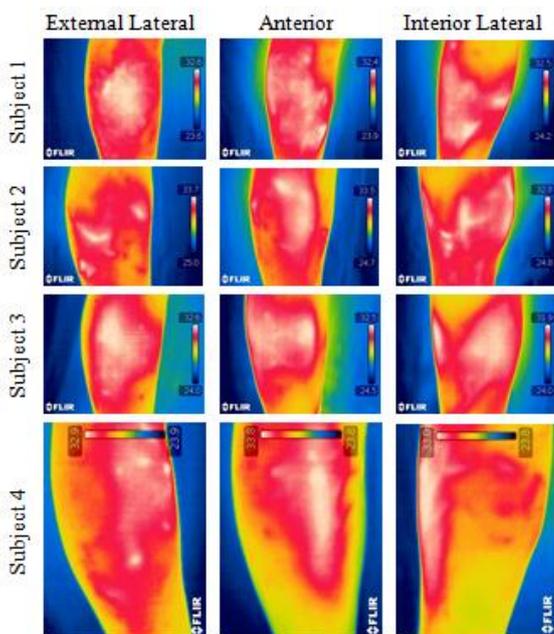
The preliminary tests were able to provide a reference for neutral situation. In Fig. 2 there are four healthy subjects. It is observed uniform temperature variations along the surface.

Fig. 2 - Right inferior limb of the healthy subjects in the anterior and lateral views.

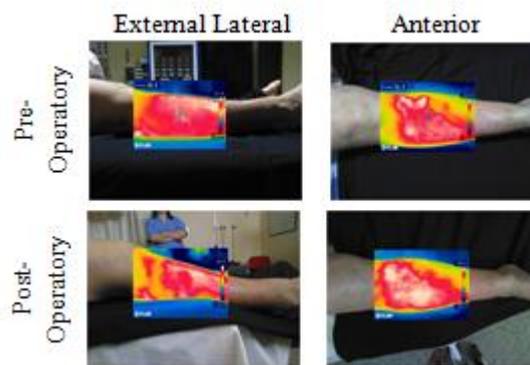
Fig. 3 - Inferior right limb before and after surgery at rest.

In this case it was not possible to identify pathology when the patient was at rest. However, the results confirmed the venous pathology and the recur-rent varicose veins when the patient was standing. It was possible identify with the thermographic exam the same findings the Eco-Doppler exam. In the post-operative images (Fig. 4) it is possible to observe residual veins that are a common complication of the surgical treatment. An alternative hypothesis refers to the ill marking of the veins in pre-operative exam. Thus an intra-operative exam would be a way to ensure the success of the surgery when the marking is not completed. The images of the post-operation were collected 39 days after the surgery.

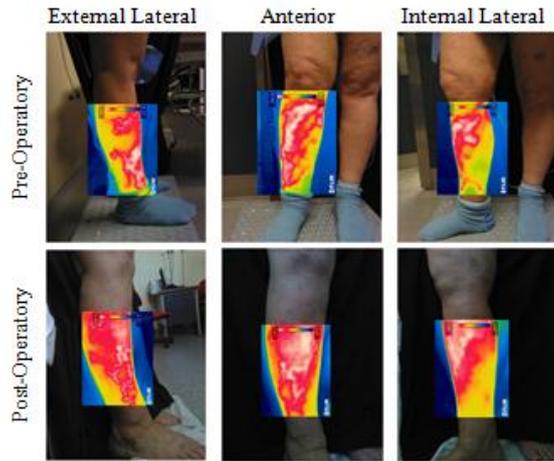
Fig. 4 - Affected limb (right leg) of the clinical case 1 before and after surgery.

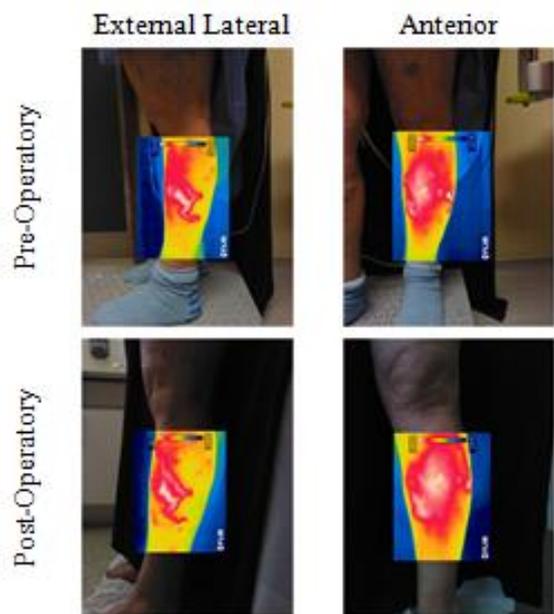
In this case there was an aggravation of the healthy leg (Fig. 5) that may be due to overload in the leg while the operated leg recovers from the surgery.

Fig. 5 - Right inferior limb not indicated for surgery. Identification of pathology in the external lateral face of the limb.

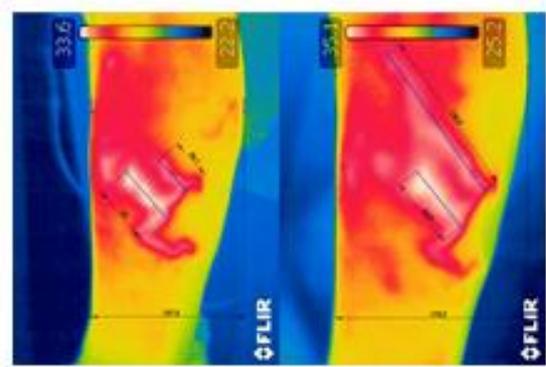
The images of the pre and post-operative were not taken always at the same distance and angles but approximate values of the vein dimension were determined by simple triangulation. One of the varicose veins of the healthy leg (Fig. 6) increased of  $232\% \pm 5\%$ .

Fig. 6 - Left leg. Varicose veins compared before and after the surgery to the right leg.

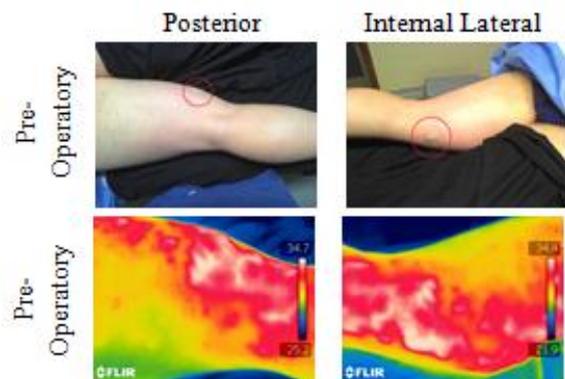
An 18 year-old male with a visible dilatation of the vein of the inferior left limb. The images were collected in pre-ambulatory environment, and in this case it was possible to identify abnormal temperature areas even when the patient was at rest (Fig. 7).

Fig. 7 - Affected limb (left leg) of the clinical case 2 before surgery (Original and thermal images).

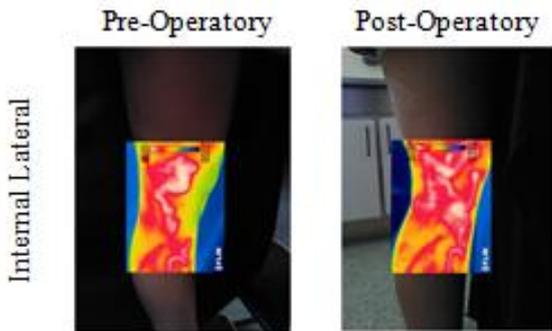
The pathology is evident and consistent with the Eco-Doppler. The saphenectomy intended to solve the main trunk of the saphenous vein. From a medical point of view the surgery was successful (Fig. 8). It was also possible to identify varicose veins in the healthy leg (Fig. 9) where the Eco-Doppler had not identified any abnormality.

Fig. 8 - Left inferior limb before and after surgery only in the lateral view.

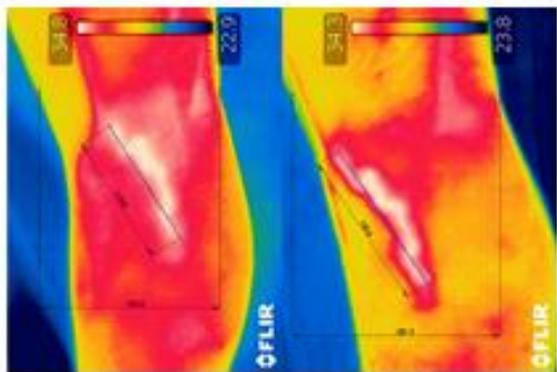
In this case the increase of the varicosity of the healthy leg (Fig. 9) was 4.3% within our margin of error. In this case we cannot conclude that there was an increase of the varicose vein in the healthy leg.

Fig. 9 - Right leg. Varicose vein compared before and after the surgery to the left leg.

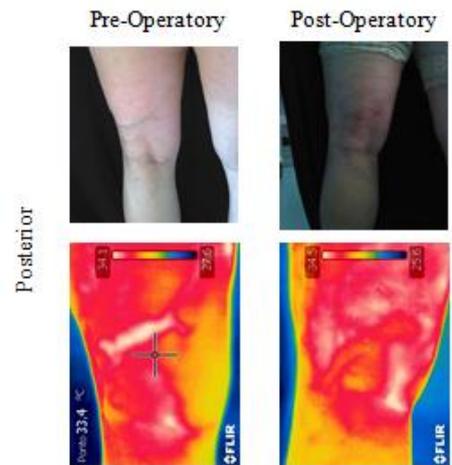
The third clinical case was of a 60-year-old female indicated for a saphenectomy in the left inferior limb. The most evident vein was located in the posterior face of the limb. In Fig. 10 it is visible the vein with the thermographic exam confirming the pathology. The images of the post-operation were collected 18 days after the surgery, and it is well perceptible the improvement of the area presenting a more uniform temperature of the intervene area. There is an improvement on the posterior face of the limb. At the post-operative consult the patient claimed to feel well and free of pain.

Fig. 10 - Left inferior limb before and after surgery.

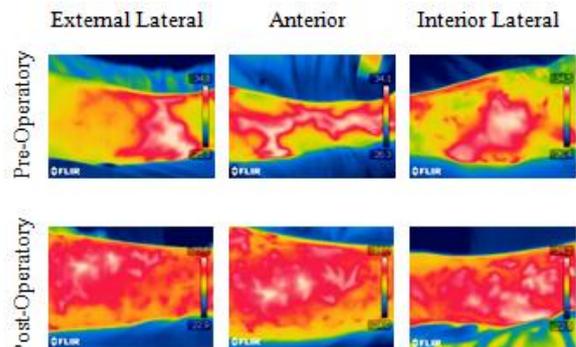
A 62 year-old female with indication of surgery to the right inferior limb. In this case it was possible to see through the thermal images the pathology very clearly even when the patient was lying (Fig. 11). Then, the venous pressure is more passive, as the pressure of the blood is lower in the veins to venous return.

Fig. 11 - Right inferior limb before and after surgery.

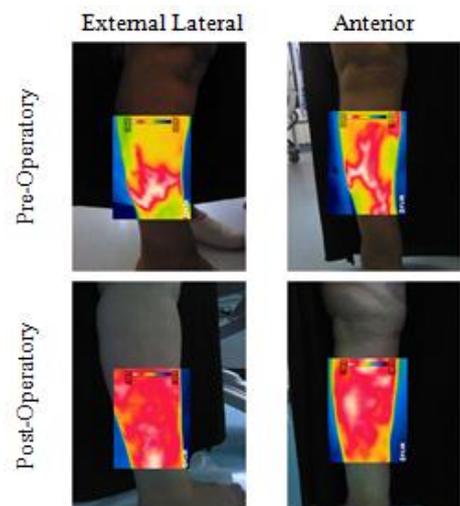
Undoubtly, the best position to visualized and diagnose varicose veins is when the patient is standing (Fig. 12). This is another case in which there was a significant improvement in the leg after surgery, observing in the post-operative a uniform surface temperature. Given that these images were collected 17 days after surgery, we can also speak on the expertise of the surgeon.

Fig. 12 - Right inferior limb indicated for surgery (pre and post-operative).

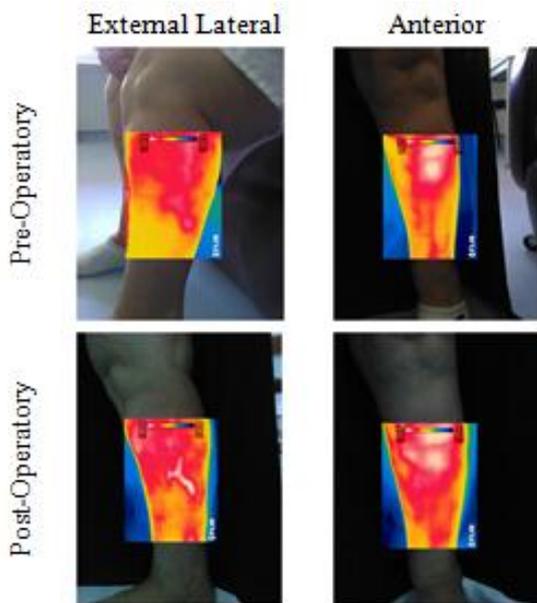
In this case was also possible to identify pathology in the healthy leg (Fig. 13). However the angle of capture of the images in the pre-operative wasn't exactly the same than the post-operative therefore is not possible to conclude if there is an evolution of the varicose vein.

Fig. 13 - Left inferior limb not indicated for surgery, before and after the operation of the right leg.

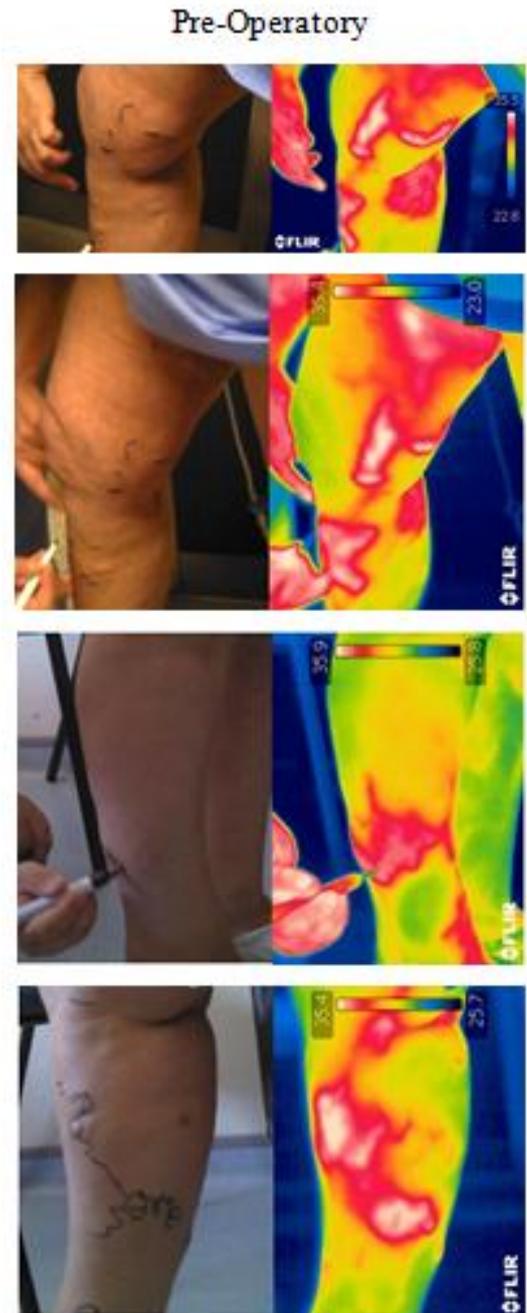
In some clinical cases, the opportunity arose to collect images while the surgeon was marking the varicose veins with a marker. In Fig. 14 we observe a surgeon tagging the leg with a marker. In this case the surgeon was guided by Eco-Doppler information and touch (by palpation of the leg). We observe that the markings are consistent with the warmer spots on the leg.

Fig. 14 - Marking of the varicose veins in the pre-operative exam.

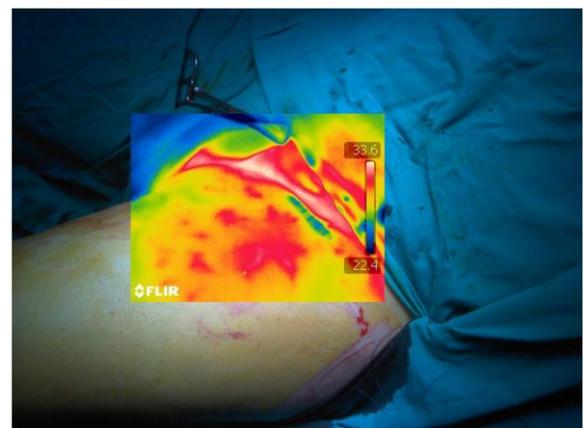
In the point of view of a surgeon, in the case 1 there were some varicosities spots to mark. In the future to help avoid these types of flaws, thermography can be a very useful technique in the support of the pre-operative exam. It would be also a great support technique as a intra-operative exam (Figs 15-16), helping the surgeon to evaluate the result of the surgery.

Fig. 15 - Intra-Operatory thermography exam.

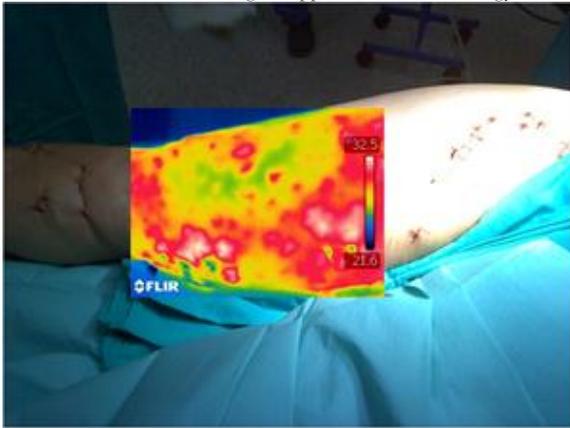
Fig. 16 - Intra-Operatory thermography exam of a saphenectomy surgery.
